## Boat Inspection and Cleaning Procedures Photographs

## Pictures of Mussel Contamination

## More Boat Inspection and Cleaning Procedures Photographs

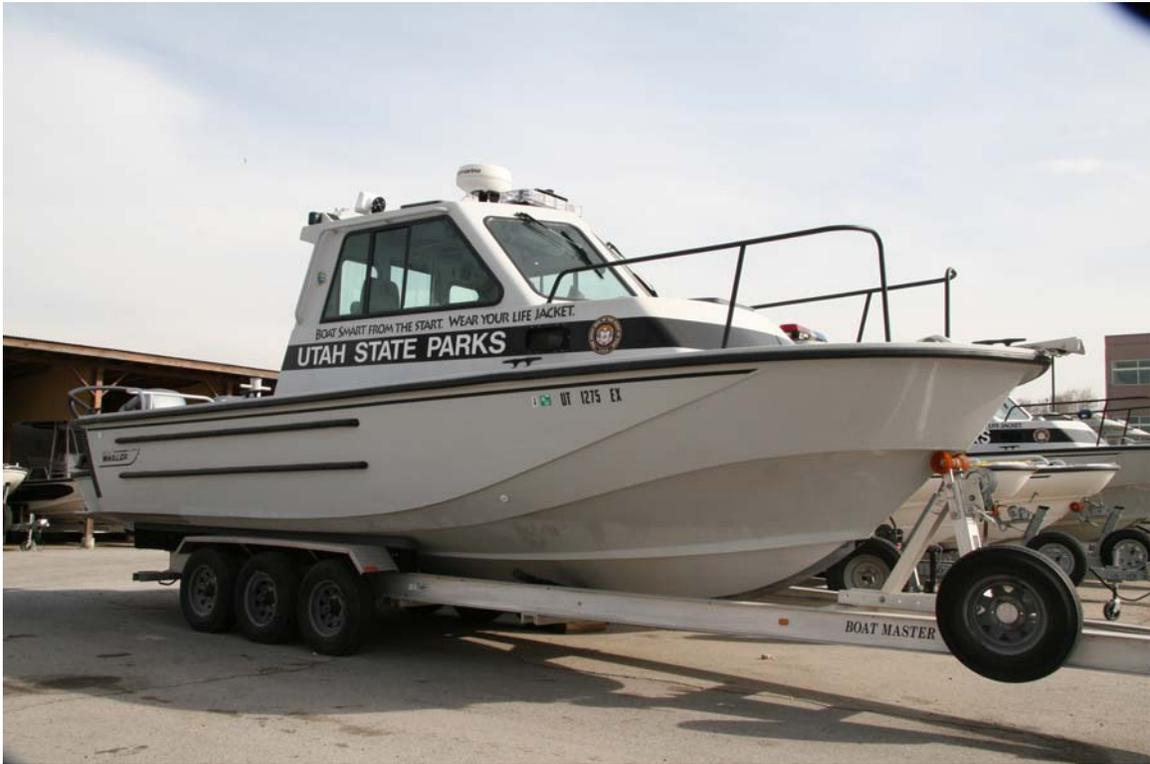
**Figure 1 Boat On A Trailer**

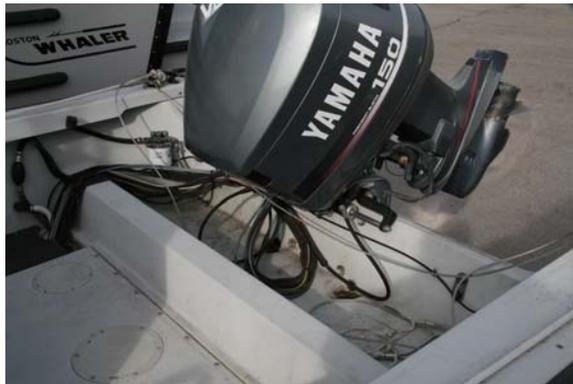
**Figure 2 Motor Well**

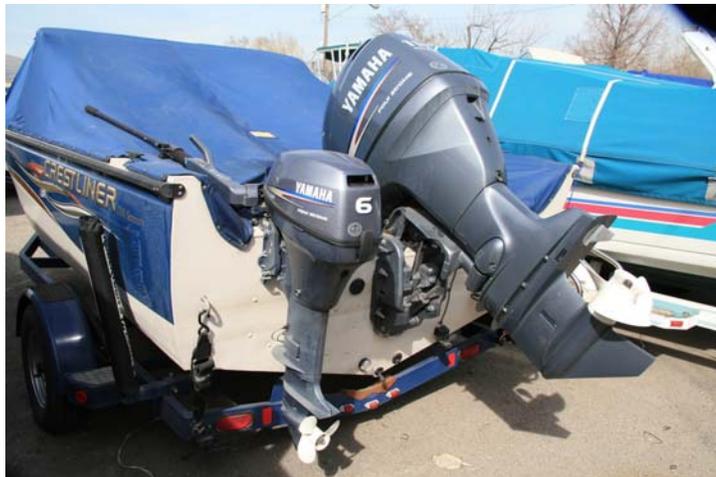
**Figure 3 Two Outboard Motors On A Transom**

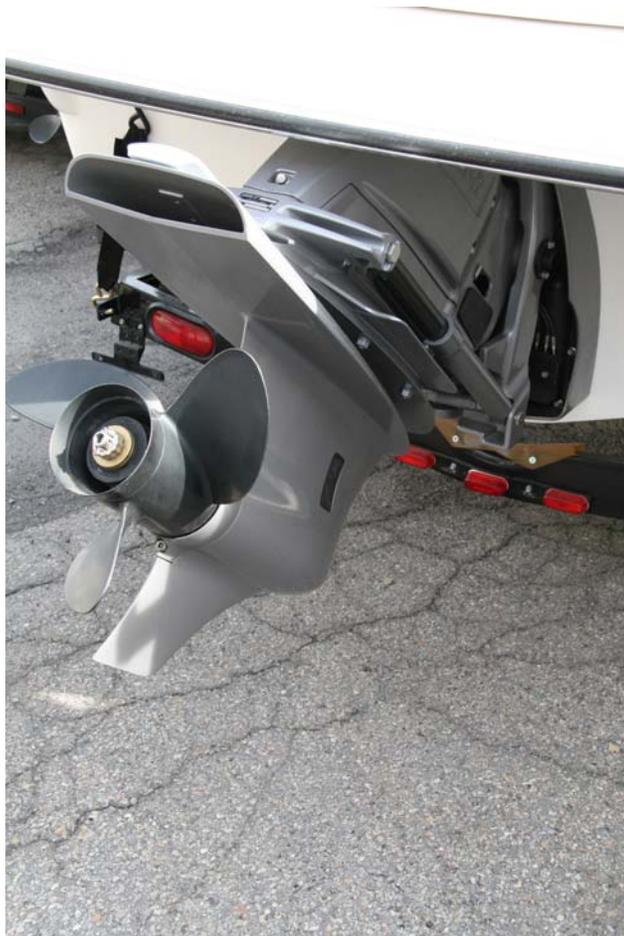
**Figure 4 Stern Drive Motor With Propeller**

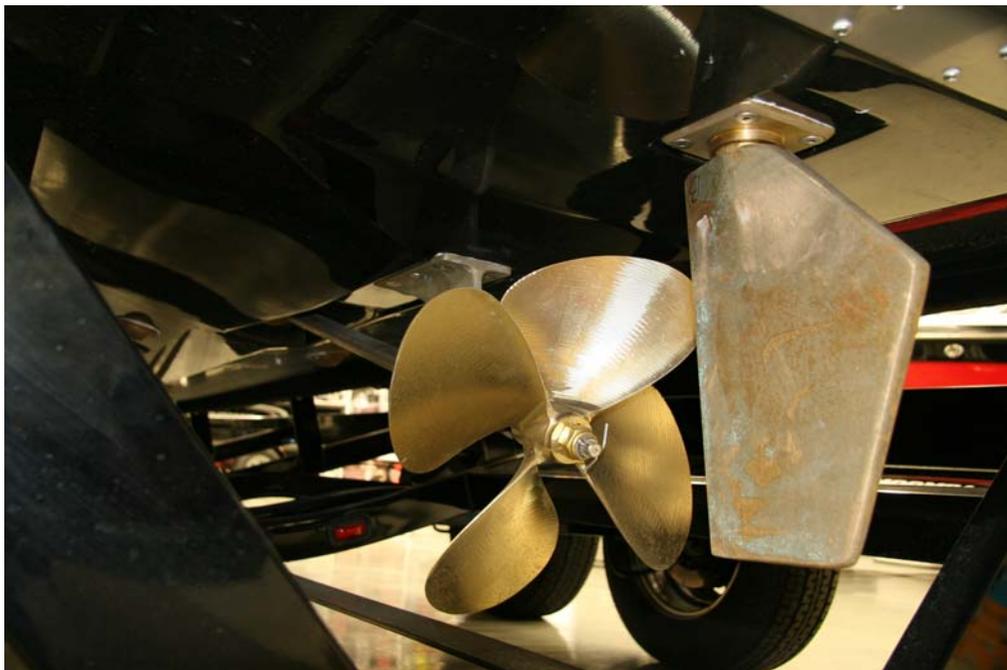
**Figure 5 Inboard Motor Boat With Propeller & Rudder**

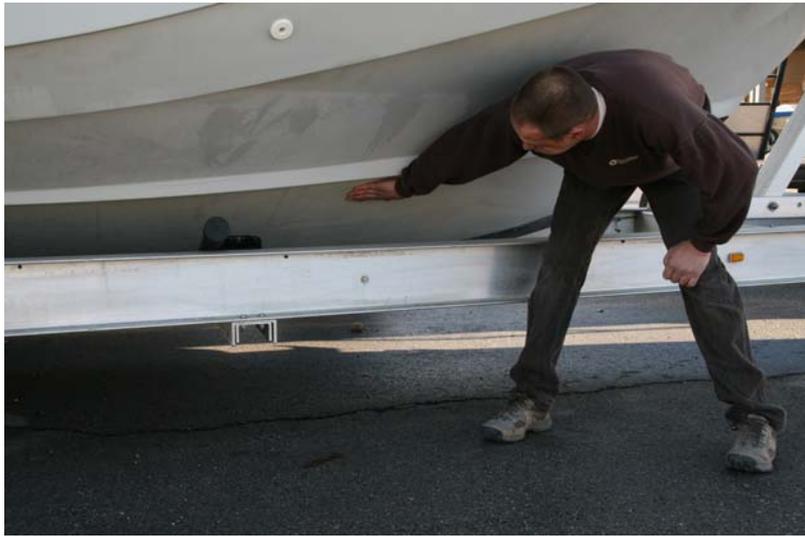
**Figure 6 Carefully Feeling For Juvenile Mussels (not dirt or mineral deposits)**

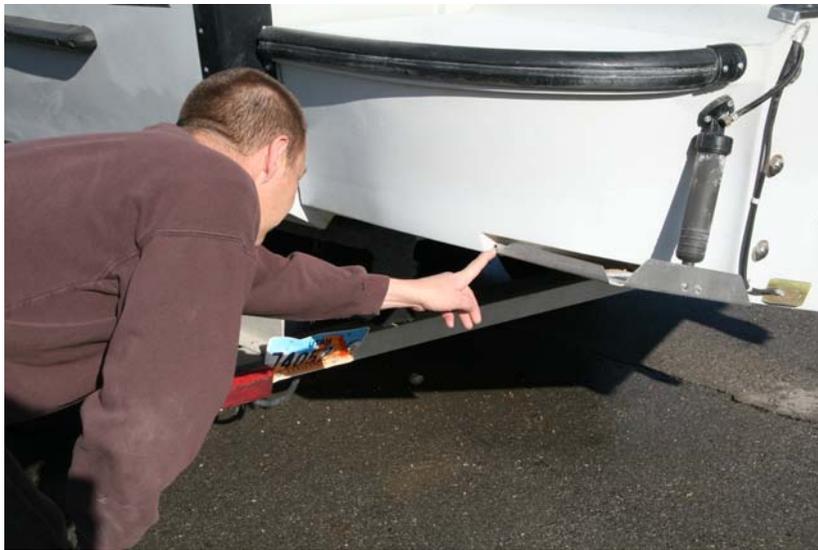
**Figure 7 Checking Trim Tab Hinge For Juvenile Mussels**

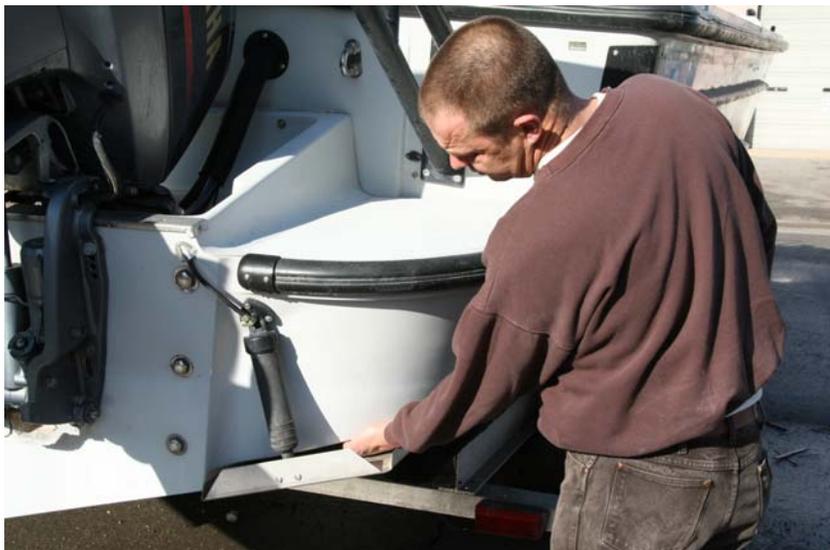
**Figure 8 Carefully Feeling Hull & Trim Tab**

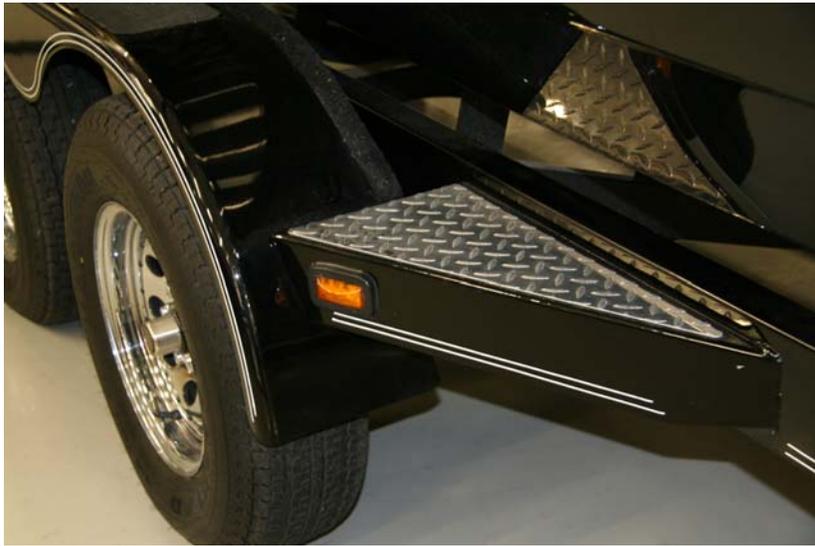
**Figure 9 Trailer Frame, Wheel, Fender & Light**

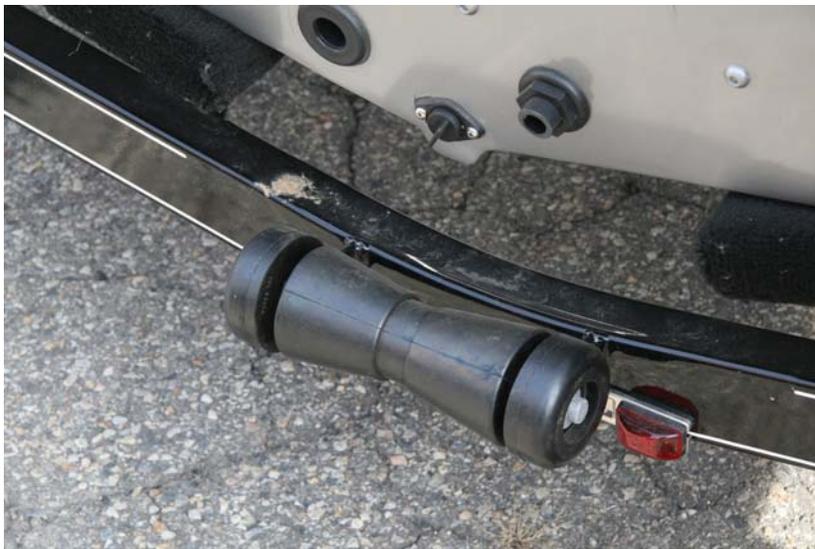
**Figure 10 Trailer Frame & Roller. (note boat drains)**

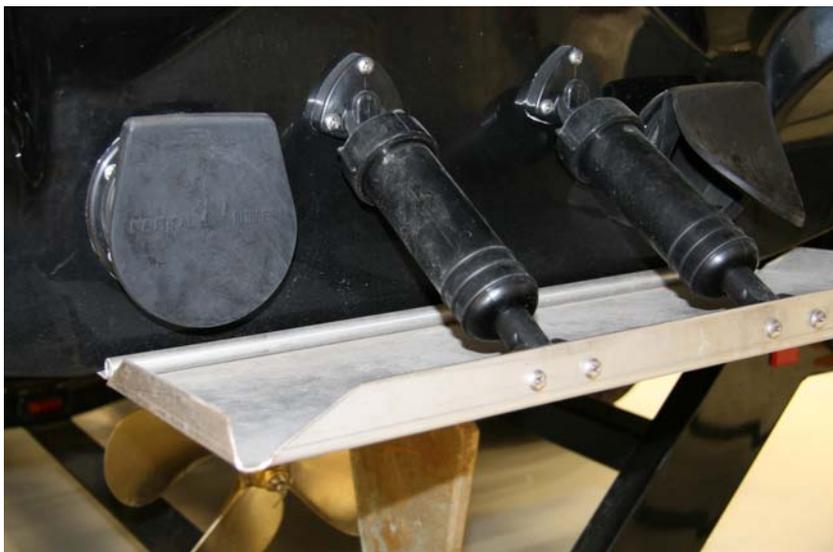
**Figure 11 Trim Tab On Transom**

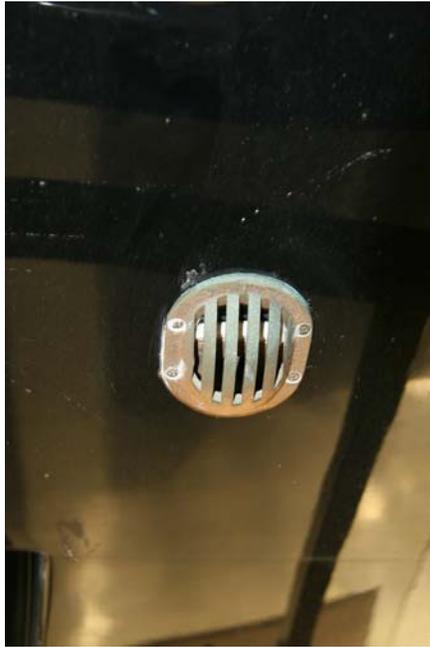
**Figure 12 Water Intake On Hull Under Boat**

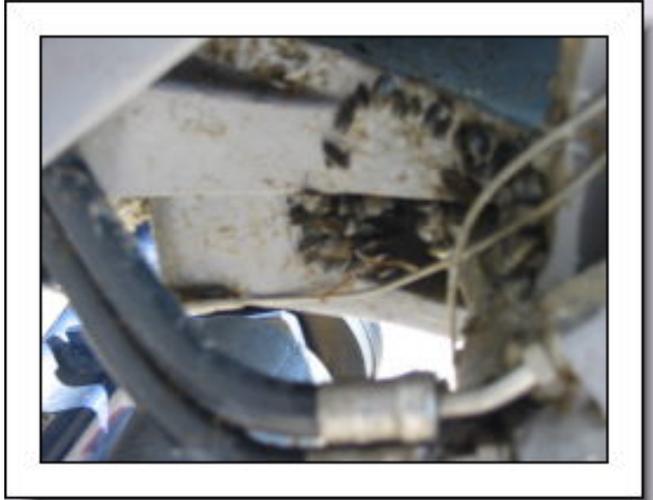
**Figure 15 Mussels Around Stern Drive**

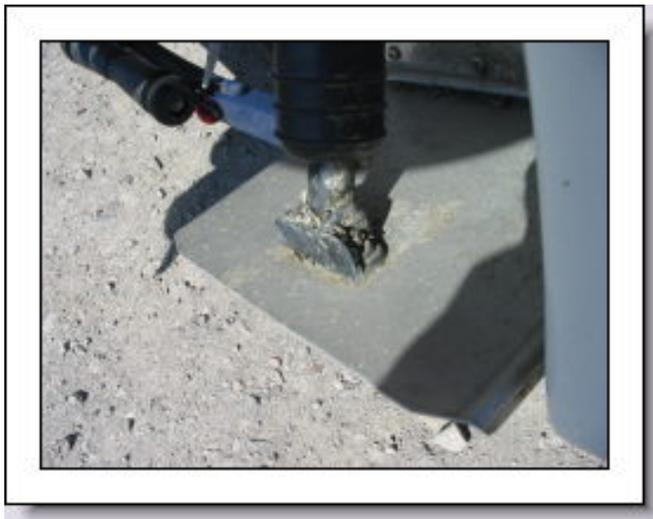
**Figure 16 Mussels On Trim Tab**

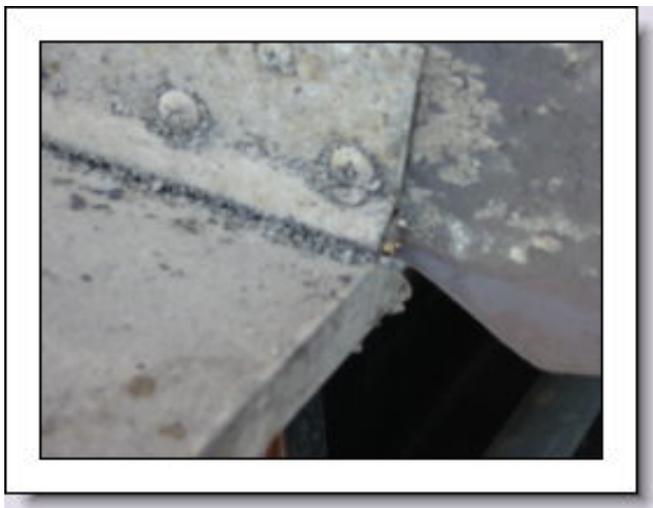
**Figure 17 Mussels On Trim Tab Hinge**

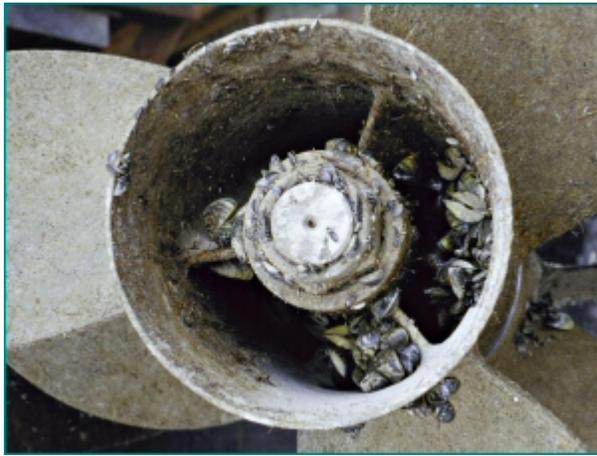
**Figure 18 Mussels Clog Propeller Assembly**

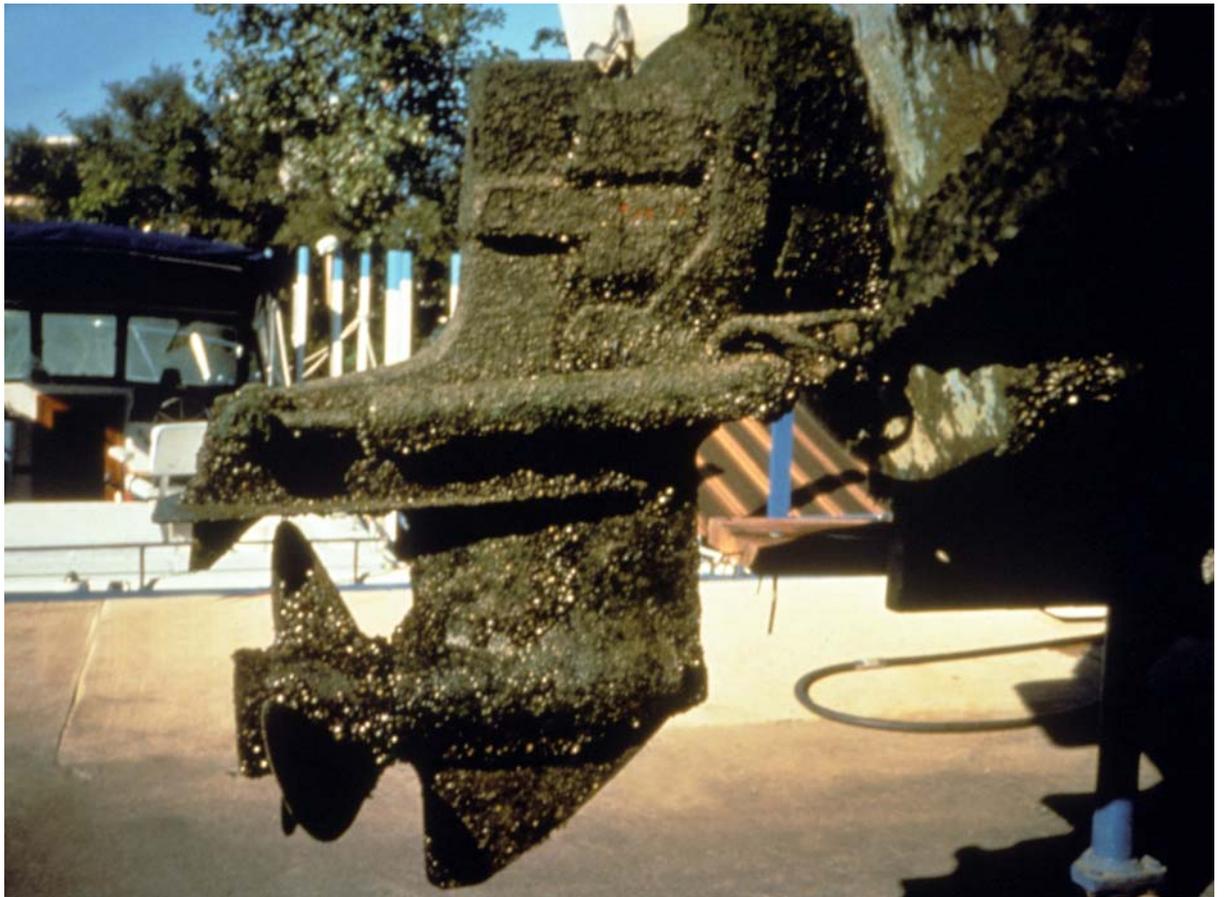
**Figure 20 Thick Mussel Encrustation On Motor & Boat**

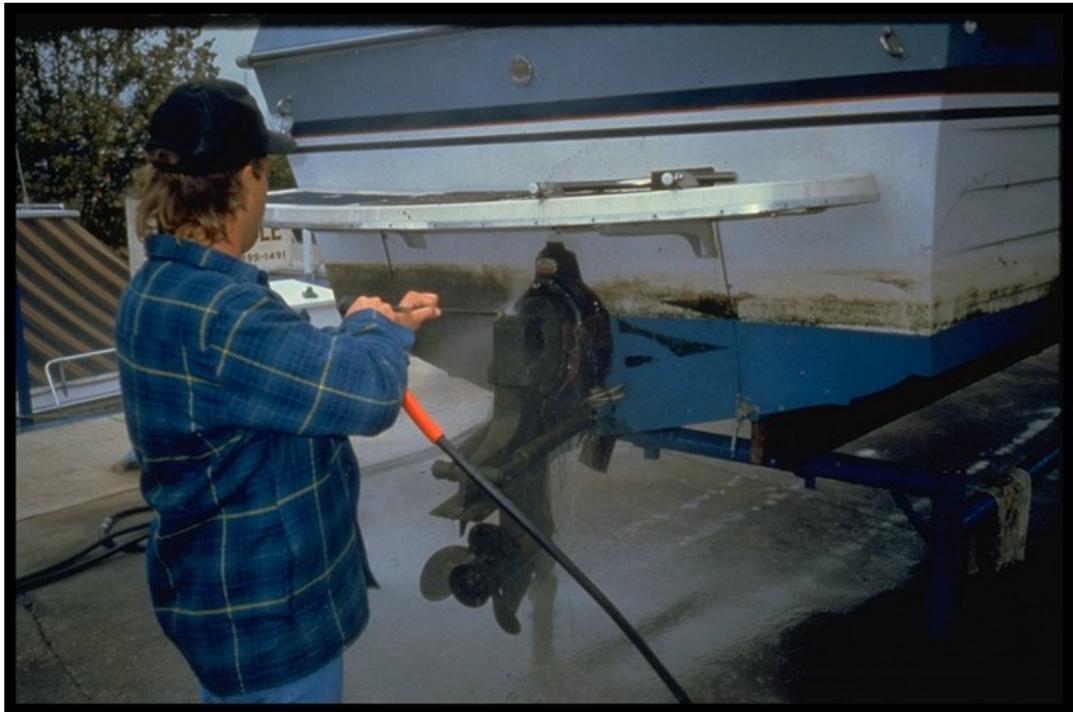
**Figure 21 Power Washing To Remove Mussels (note clean right side compared to left side)**

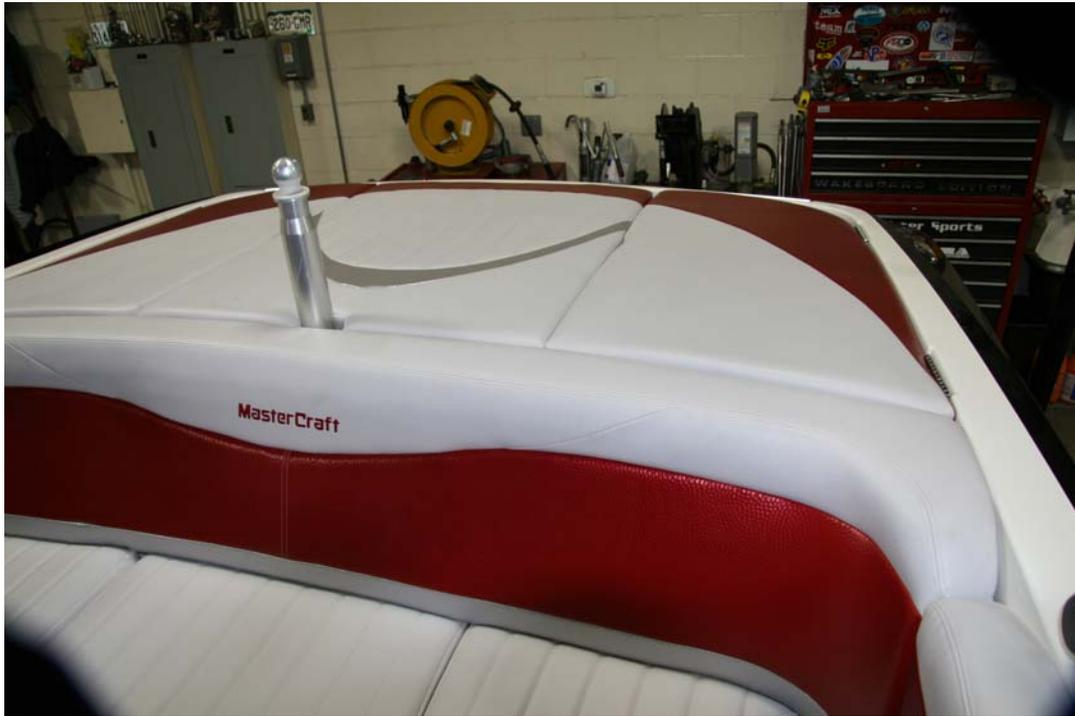
Figure 23 Water Ski Boat Rear End Engine and Ballast System Equipment Below Covers

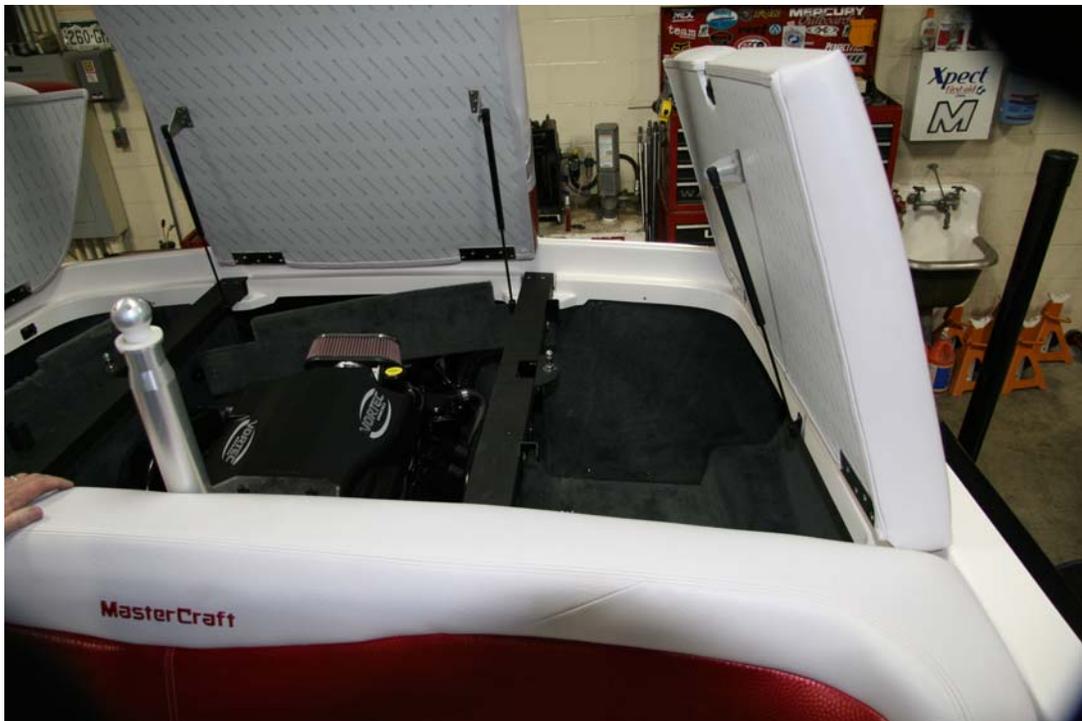
Figure 24 Water Ski Boat Rear End With Covers Open

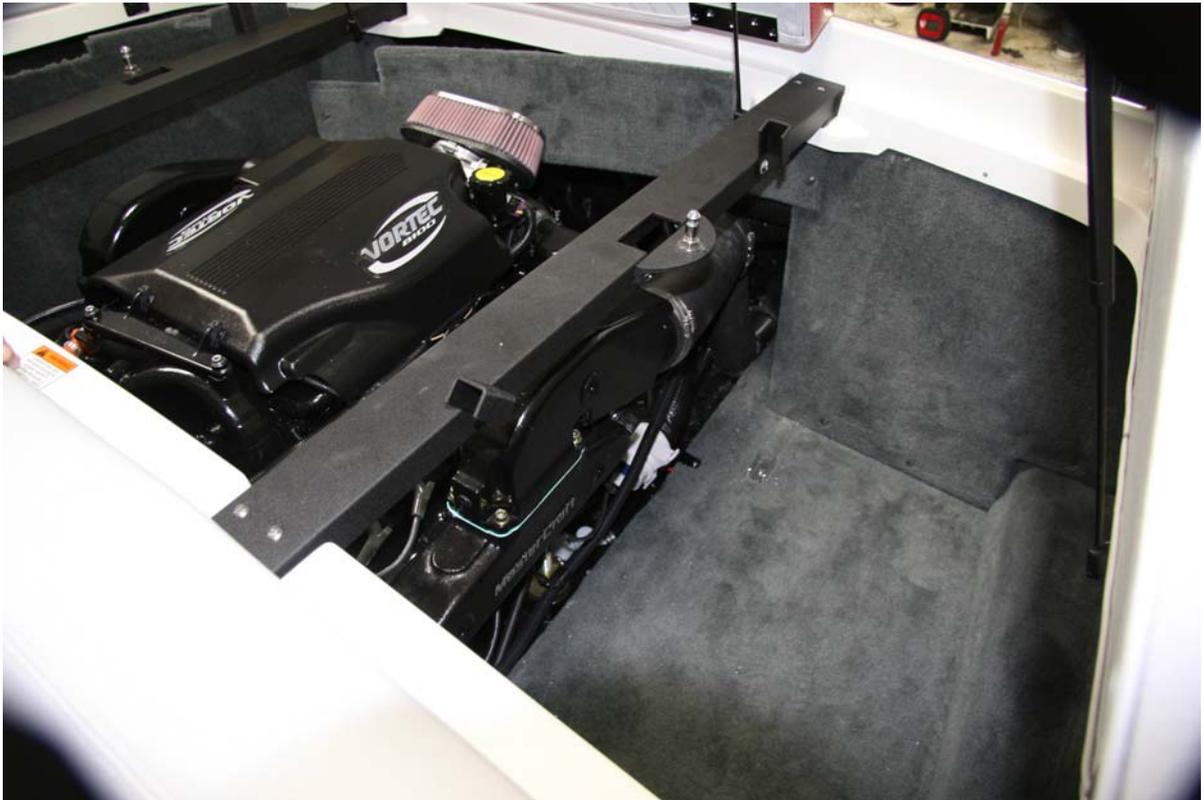
**Figure 25 Water Ski Boat -- Ballast Water Lines Running Alongside Engine (small white caps)**

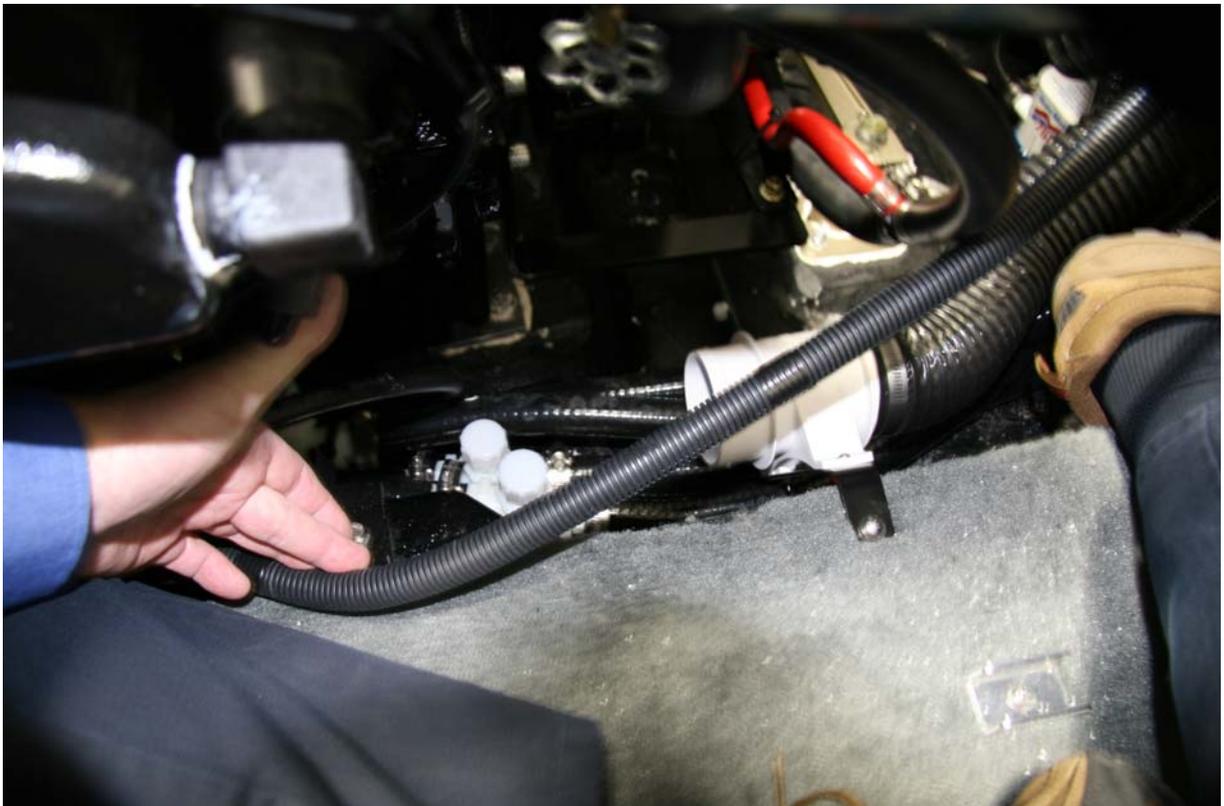
**Figure 26 Ballast System Water Lines - Small White Access Caps (used to introduce mussel-killing solution)**

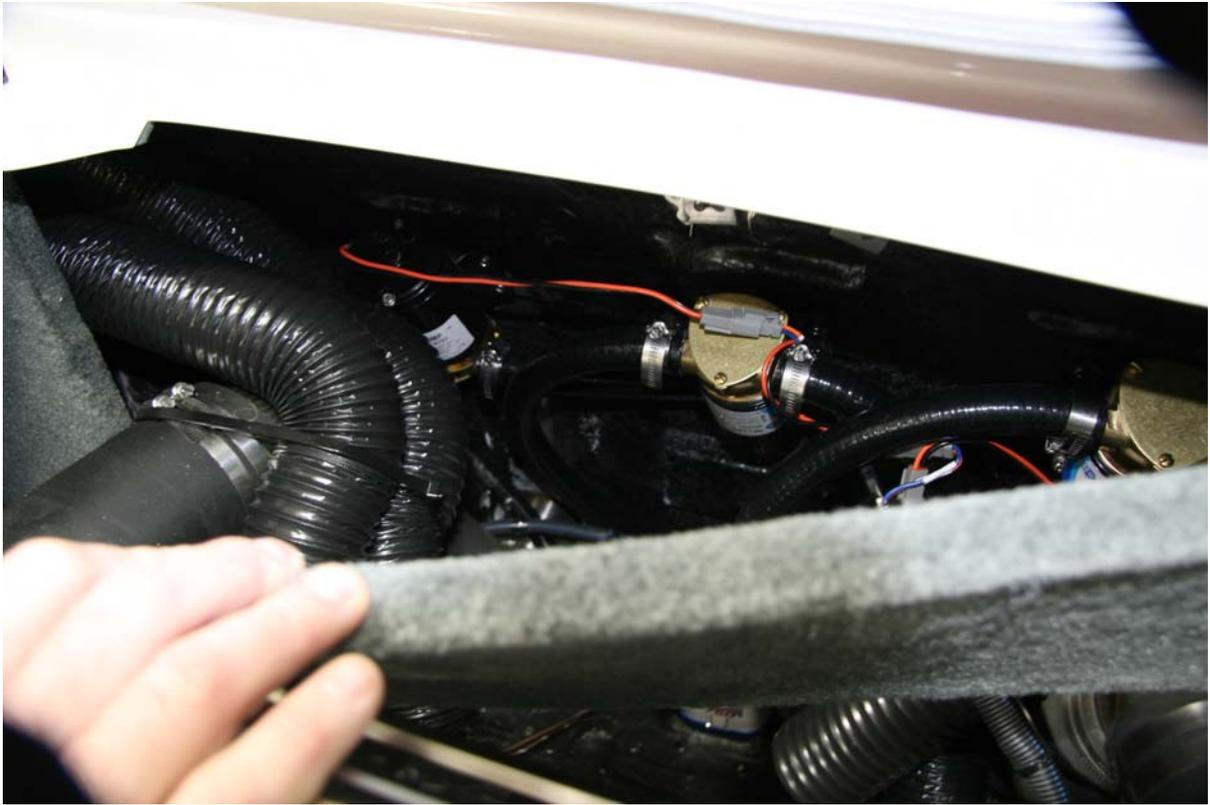
**Figure 27 Ballast System Water Pump**

**(mounted on transom, center of picture, one of three)**

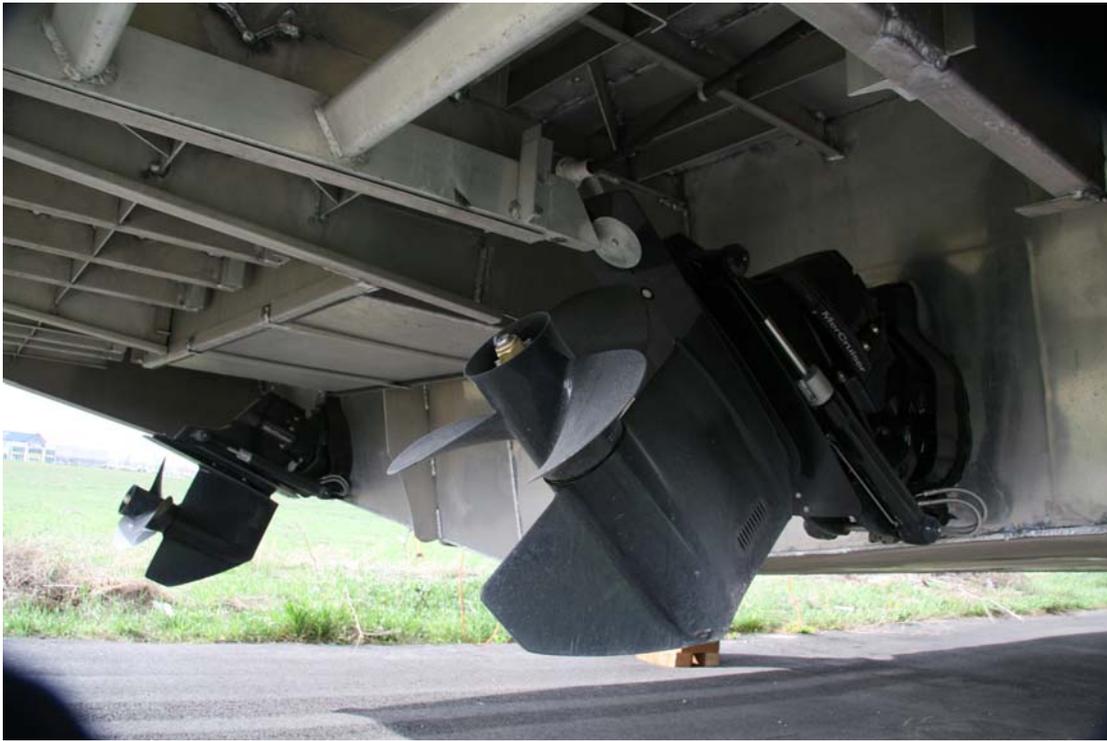
**Figure 31 Houseboat Back End With Motors** (lots of places for mussels to attach & infest, hard to clean)

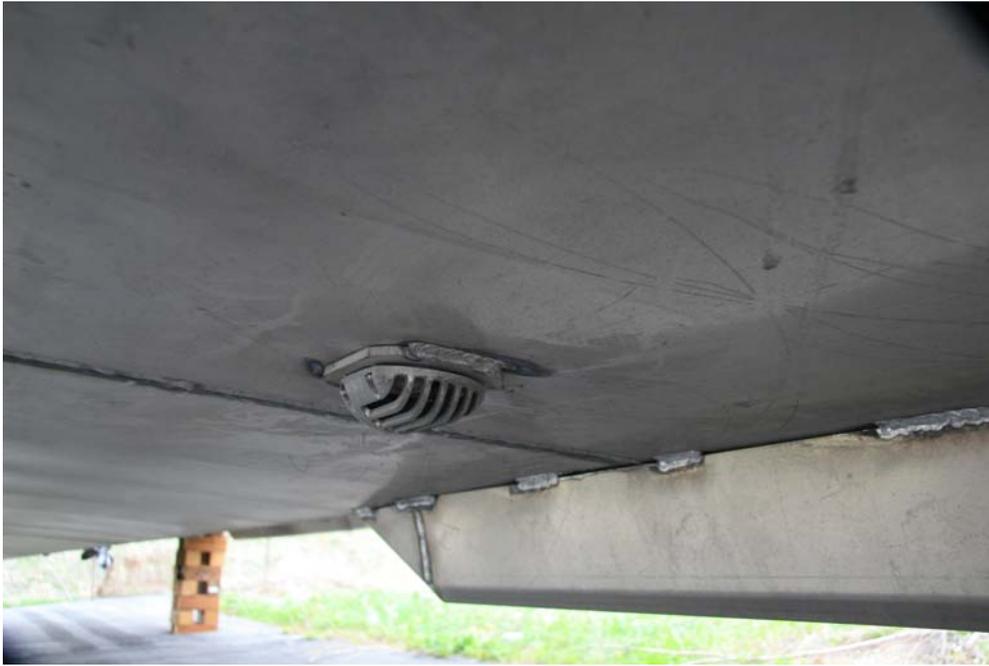
**Figure 33 Underside of Houseboat With Water Intake** (one of several on a typical houseboat)

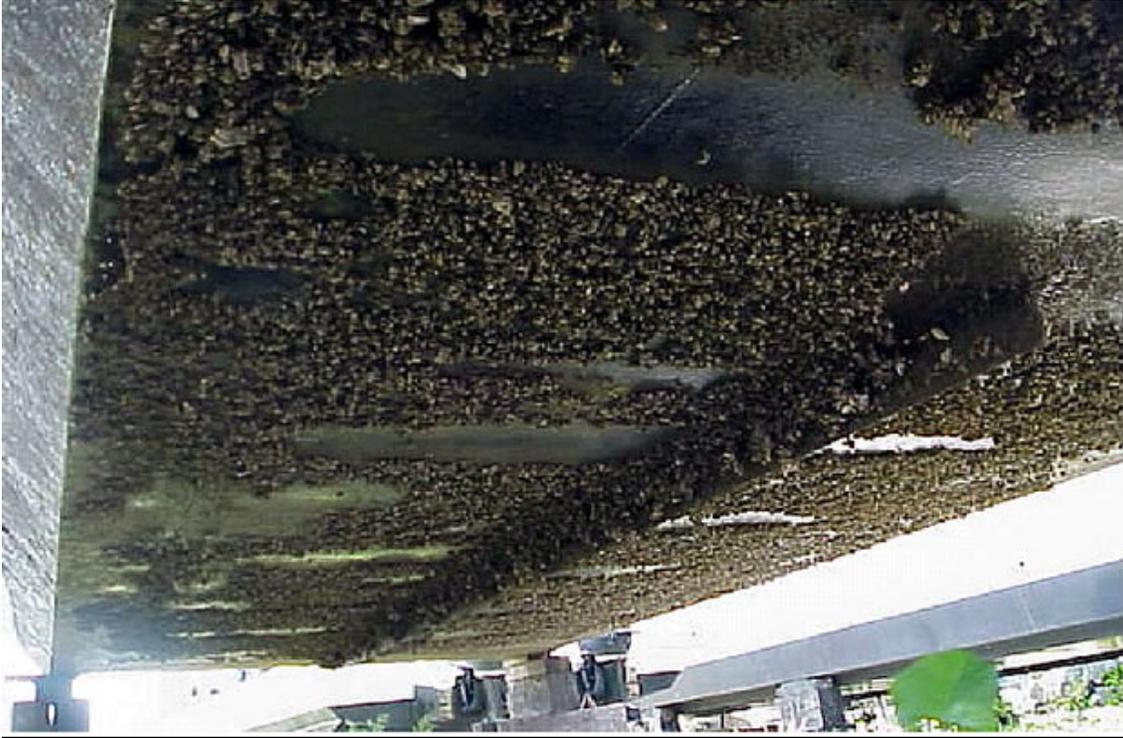
**Figure 35 Flat- Bottom Boat With Mussels** (think houseboat with water intakes)

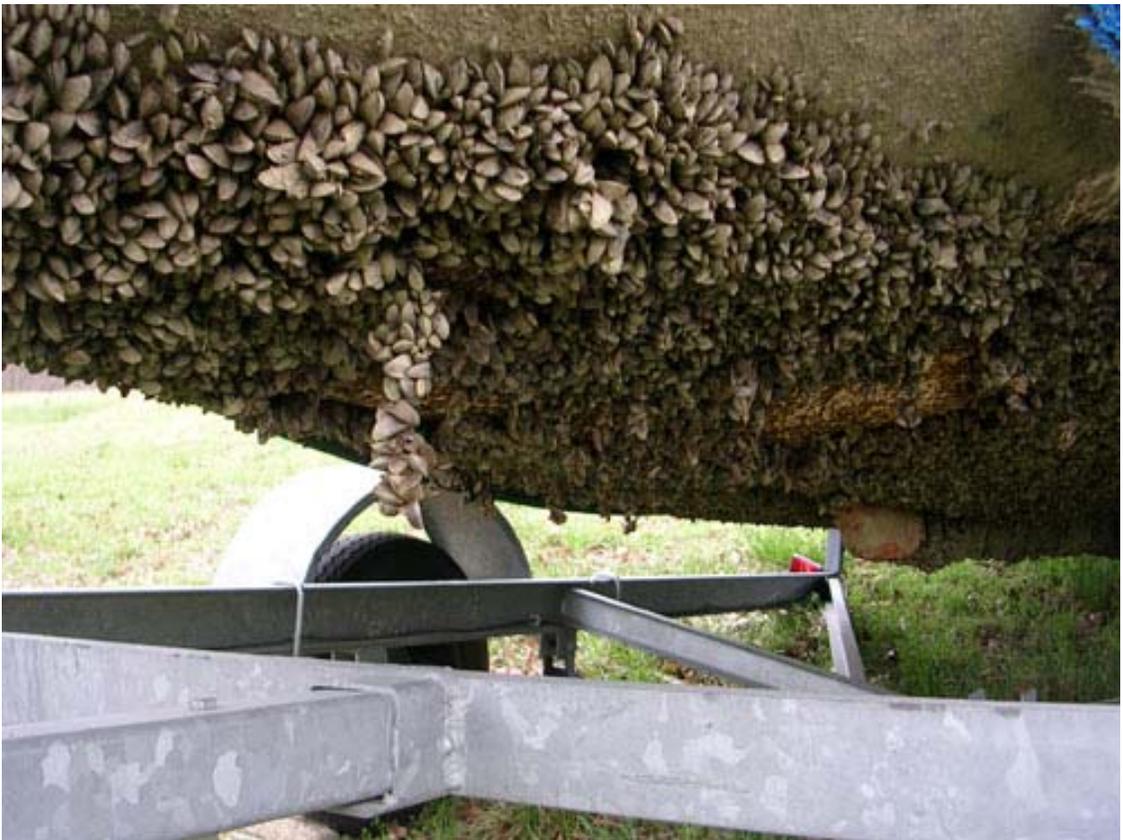
**Figure 36 Seriously Mussel-Encrusted Sailboat Bottom** (note where centerboard would fit)

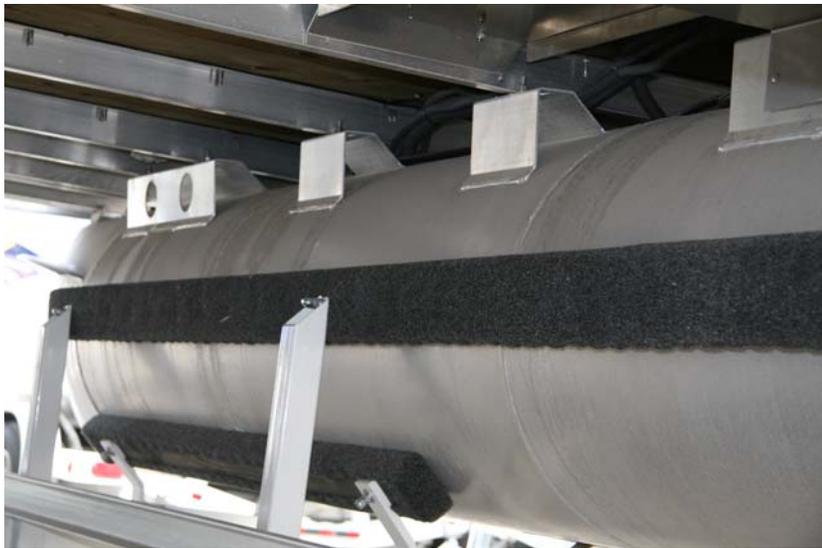
**Figure 38 Pontoon Boat Underside Details**

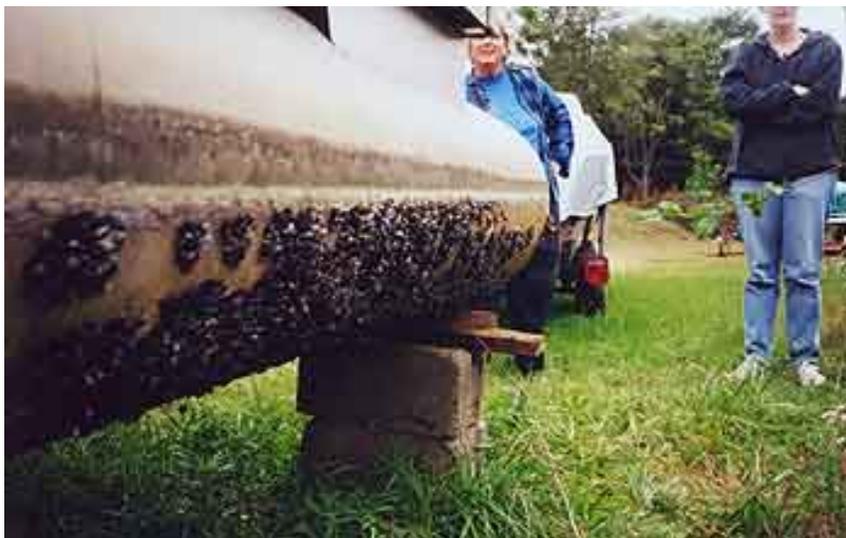
**Figure 39 Pontoon Boat With Mussel Infestation**

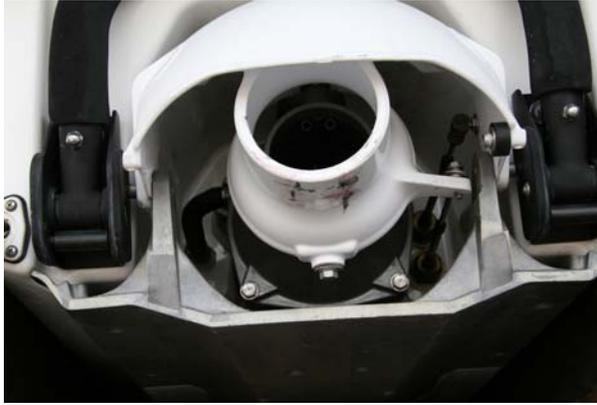
**Figure 40 Personal Watercraft Steering Nozzle**

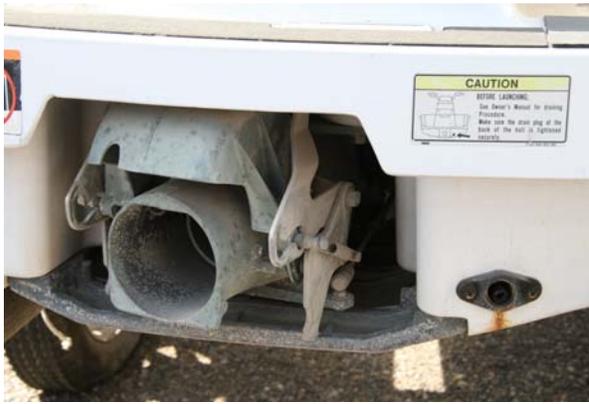
**Figure 41 Personal Watercraft Steering Nozzle (note hull drain)**

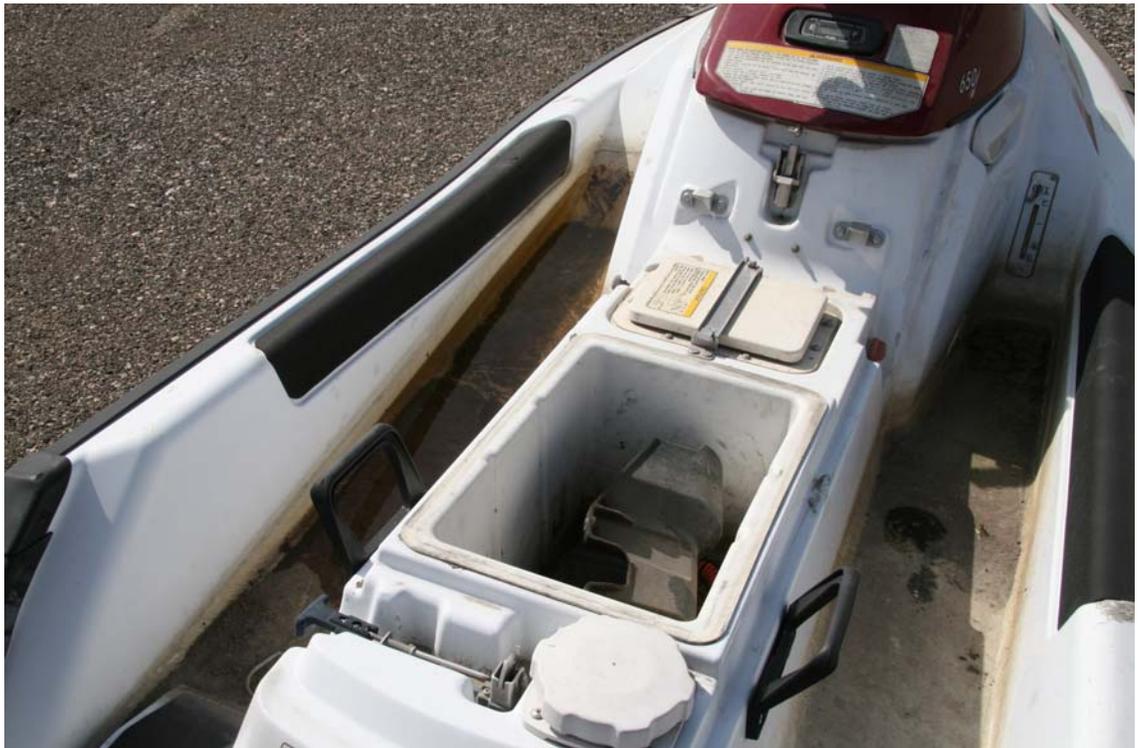
**Figure 42 Personal Watercraft With Water In Foot Recesses**
